Monitoring Irrigation at Container Nurseries

Donna C. Fare,
Charles H. Gilliam,
and Gary J. Keever

Summary. Efficient usage of current water supplies is of great concern to container-nursery producers. Improving water management first requires knowledge of current commercial container production practices. In this study, irrigation distribution from overhead sprinklers was monitored at container nurseries to determine the distribution and the amount of irrigation applied during a typical irrigation cycle. Several nurseries surveyed had poorly designed irrigation systems; subsequently, irrigation distribution varied widely at sampling dates and within the growing-container block. Uniform distribution was achieved at some nurseries, but required careful monitoring of the irrigation system. Future water restrictions may force nurseries to improve water usage by changing irrigation delivery methods to minimize water use, resulting in reduced surface runoff and effluent from container nurseries.

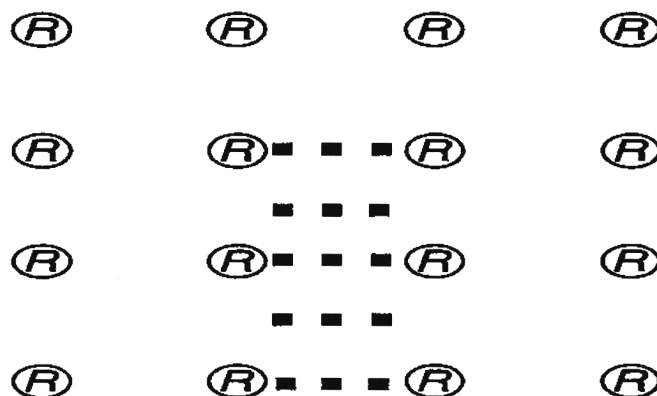
Ⓡ Riser
■ Rain gauge
— Edge of container block

Fig. 1. Riser and rain gauge locations for irrigation sampling. See Table 1 for riser spacing in nurseries 1, 2, and 4.

Taylor rain gauges [8-inch (20-cm) height; Taylor Instruments, Arden, N.C.] were placed in plant containers to collect irrigation water over 1 h. The plant container gave stability to the gauge and ensured the gauge opening was slightly higher than the plant canopy. Fifteen gauges were located in a grid system between or around irrigation risers within a container block in each nursery (Figs. 1 and 2). When plants were spaced in

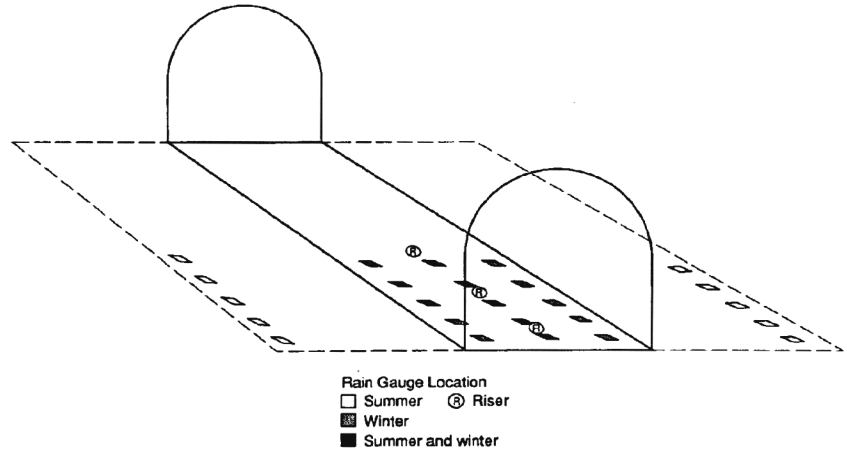
Fig. 2. Riser and rain gauge locations in winter and summer relative to over-wintering structures in nurseries 3, 5, and 6.

nurseries 3, 5, and 6, gauges were spaced farther apart (Fig. 2). Gauges were placed at the same locations at each sampling in nurseries 1, 2, and 4. At all nurseries, similar grid patterns for gauge location were used, even though each nursery had a different irrigation system design, including various riser heights, riser spacings, and nozzle types (Table 1). Calm con-

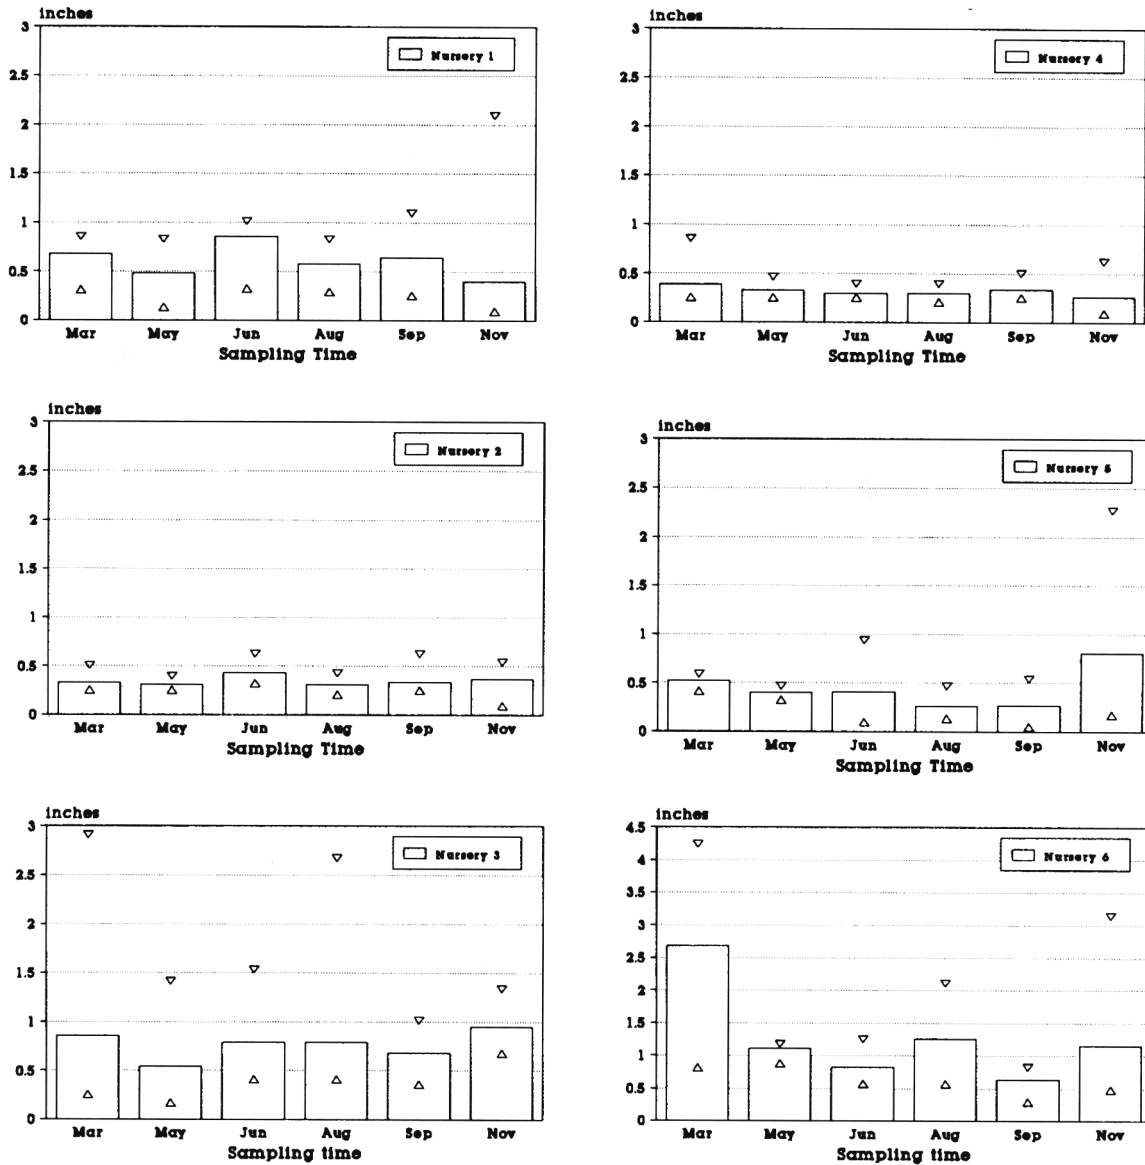
Fig. 3. Irrigation application distribution at six container nurseries in Alabama sampled monthly after 1 h of irrigation. Irrigation ranges are shown between A, and bars indicate means of 15 observations.

Results were similar for the two years of the survey, hence only data from 1990 are reported. Average irrigation volumes applied varied widely from nursery to nursery (Fig. 3). For example, the average irrigation collected during a 1-h period in nurseries for the six sampling times ranged from 0.3 inch (0.8 cm) in nursery 5 to 1.3 inch (3.2 cm) in nursery 6, a 4-fold difference. Excluding nursery 6, the average irrigation collected over the remaining five nurseries was 0.6 inch (1.6 cm), or slightly more than half of the 1 inch that most growers assumed they were applying during a 1-h irrigation. An average of < 0.5 inch (1.3 cm) of water was applied during a 1-h irrigation at three of the nurseries (nurseries 2, 4, and 5), while an average of 0.7 inch (1.8 cm) was applied in nurseries 1 and 3. Variation in irrigation among the sampled nurseries may relate to differences in nozzle type, delivery pressure, riser height, and spacing (Table 1).

nursery 1, 0.9 inch (2.2 cm) was collected in June, but only 0.4 inch (1 cm) was collected in November during a 1-h irrigation. In nursery 3, the average irrigation collected ranged from 0.6 inch (1.4 cm) in May to 0.8 inch (2.3 cm) in November. In contrast, with nurseries 2 and 4, the hourly irrigation averages were between 0.3 and 0.4 inch (0.7 and 1.0 cm) for all of the sampling times (Fig. 3). These data demonstrate that uniform irrigation distribution can be achieved and that there is a need for careful monitoring of the irrigation system to ensure efficient water usage and minimize potential water runoff.

Temporary covering of winter-protection structures altered irrigation volumes measured. Nursery 6 used polyethylene-covered overwintering structures that confined irrigation to a smaller area and resulted in almost three times the irrigation applied in March as in the other five months of sampling, 2.7 vs. 1.0 inch (6.8 vs. 2.5 cm). A similar situation occurred in nursery 5, where irrigation from the November sampling (overwintering structures were covered) averaged 0.8 inch (2 cm), while the other five sampling dates averaged 0.4 inch (0.9 cm).

Irrigation distribution varied widely in the overwintering structures. For example, at nursery 6 during March (covered structure), irrigation ranged from 0.8 inch (2.0 cm) to 4.3 inches (10.8 cm). During the growing season (May to September), when the polyethylene was removed and plants were spaced, the irrigation distribution range was less, ranging from 0.5 to 2.1 inches (1.4 to 5.3 cm) among the 15 gauges.

Uneven water distribution within a block of plants occurred in all nurseries on at least one sampling date. Variations in irrigation volumes were not confined to overwintering structures, but were due to other unidentified factors. Within-block variations were relatively low in nurseries 2 and 4 during May through September, but in August at nursery 3, irrigation ranged from 0.5 inch to 2.6 inches (1.3 to 6.6 cm).
